## **RAILWAY INVESTIGATION REPORT**

**R99S0071**

### **CROSSING ACCIDENT**

**VIA RAIL CANADA INC.**

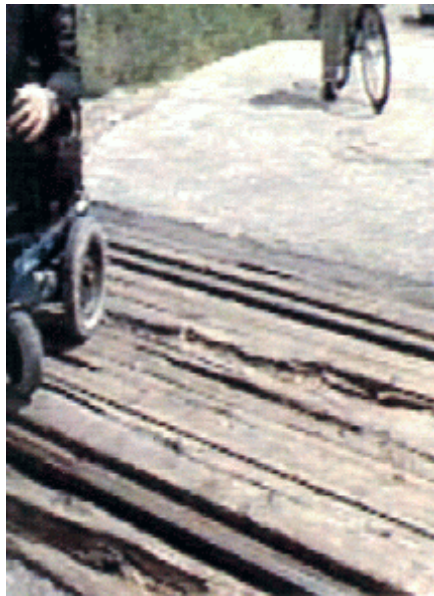
Figure 2 -The crossing planking was in very poor condition.

It is probable that the roughness of the poorly maintained approaches and planking affected the control of these wheelchairs to the extent that the front castors were oscillating, or bouncing, and they easily fell into the flangeways.

1. The persons in the wheelchairs became immobilized at the crossing when their wheelchairs became stuck in the flangeways adjacent to the running rails. The flangeways were slightly wider than the width of the front wheels. The width and depth of the flangeways were such that it was not possible for the occupants to extricate themselves.
2. The deteriorated condition of the crossing planking and the asphalt approach to the crossing probably led to a loss of steering control of the wheelchairs.

Subsequent to the crossing accident, railway officers from Transport Canada's (TC) Ontario Region, along with supervisors from Canadian National (CN) and the City of Windsor, inspected the crossing. As a result, the crossing planks were immediately replaced.

Another CN inspection of the newly installed crossing surface determined that a further enhancement to safety could be achieved by paving the crossing surface. The planking which was installed immediately after the accident was removed and replaced by an asphalt surface, with flange and mud rails on either side of the rails. Underbrush and vegetation growth along the right-of-way in the four sighting quadrants were also cleared within two weeks of the accident.

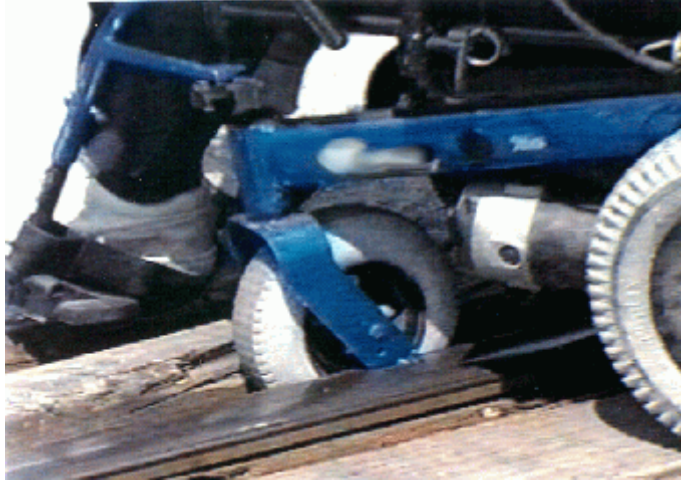
The crossing planking was located such that it provided a space for train wheel flanges to move safely through the crossing. Transport Canada's (TC) *Railway-Highway Crossing at Grade Regulations* require that a flangeway, with a width of between 65 mm and 120 mm to a depth of between 50 mm and 75 mm, be provided between the gauge side of the running rail and the highway surface. The typical width of front wheels for power-assisted wheelchairs with pneumatic tires is between 45 mm and 50 mm. Figure 3 shows a typical power-assisted wheelchair with a castor wheel in the field side of the rail.

Figure 3 - Wheelchair of the same type as one of those involved in the accident, but not with identical specifications, with a castor wheel in the field side of the rail.

Given the current designs of the majority of power-assisted wheelchairs, and despite the TC future requirement for a smooth crossing surface, a control problem will still be likely at any grade crossing when traversing the flangeways. The flangeways, which will be required to be between 65 mm and 80 mm in width, will continue to cause problems for power-assisted wheelchair operators attempting to negotiate a crossing, because of the small width and limited directional controllability of the castors typically on the front of the wheelchairs.
